Culvert corroded? Question conditions

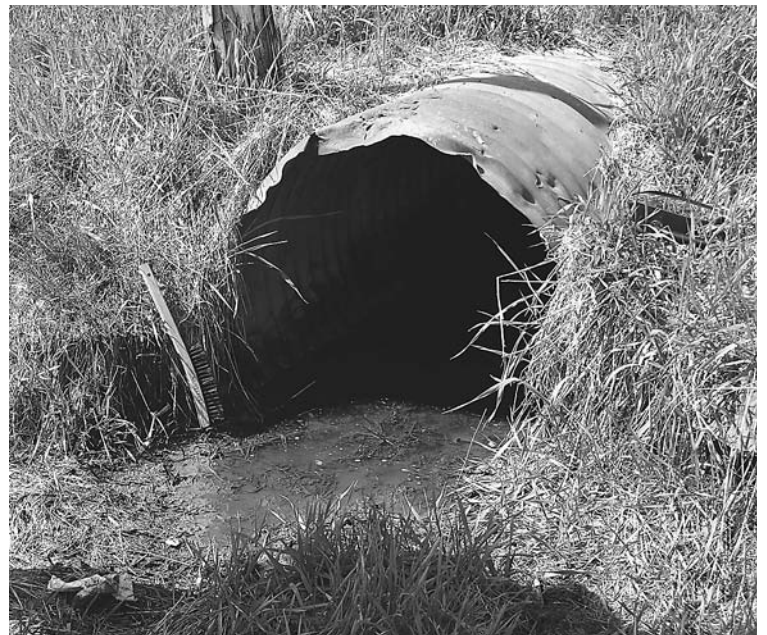
Poor installation left this culvert lower than the ditches. Constant standing water quickly rusted through the bottom.

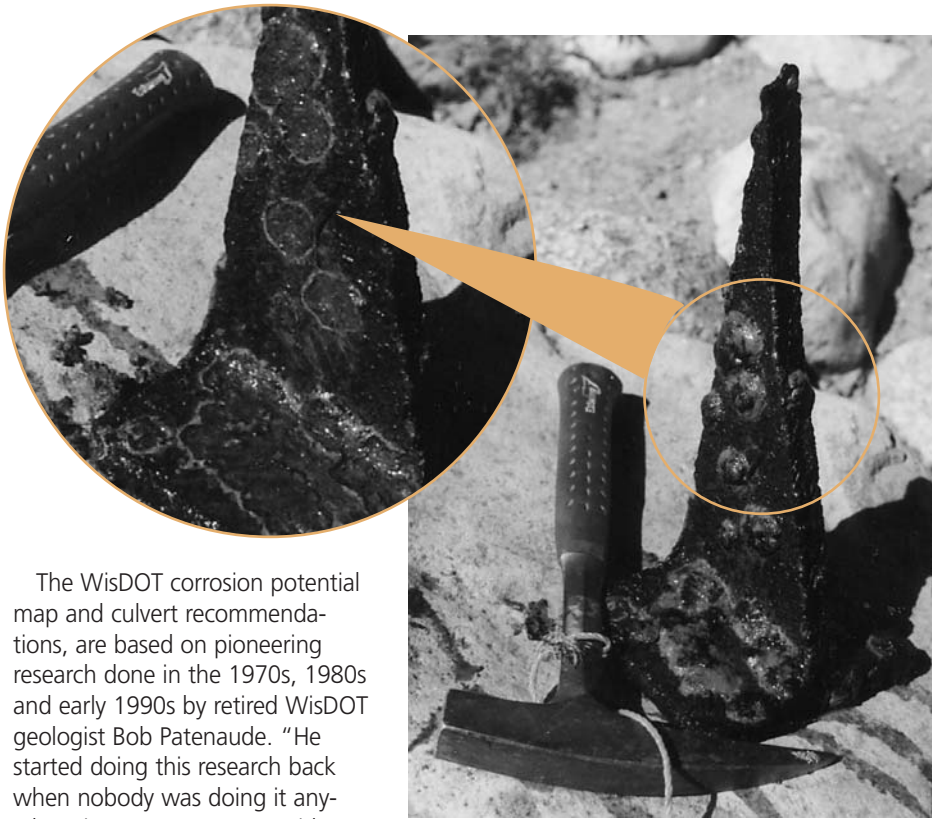
LEFT Corrosion in the form of nodules was likely caused by bacteria. In closeup, nodules have been removed revealing underlying pits.

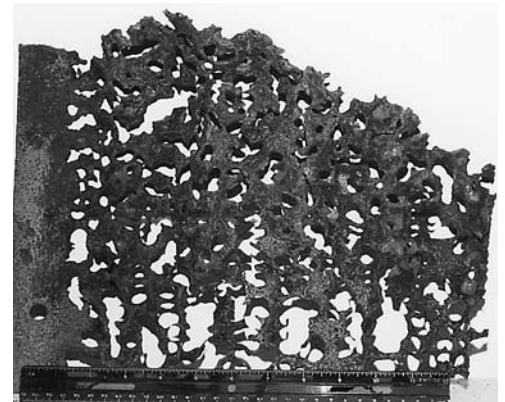
If corrosion takes the form of nodules, and small discrete holes the size of a dime appear, bacteria are likely the cause. Bacterial corrosion will tend to concentrate along the flow line where water flow is variable. These bacteria (called anaerobic sulfate reducing bacteria) do not attack the steel directly but create an environment favorable to corrosion. They thrive primarily in the north central part of Wisconsin where water alkalinity is low and are most active at sites of flowing water where the alkalinity is less than 120 ppm and the pH is 5 to 7.

Bacterial corrosion severely perforated this 10-gauge pipe arch invert. Nodules have dried and fallen off the metal.
