CROSSROADS

Bridge replacement solution saves money and time

The county needed an effective fix at a reasonable cost that put the bridge back in service soon. They found one in an aluminum box culvert.

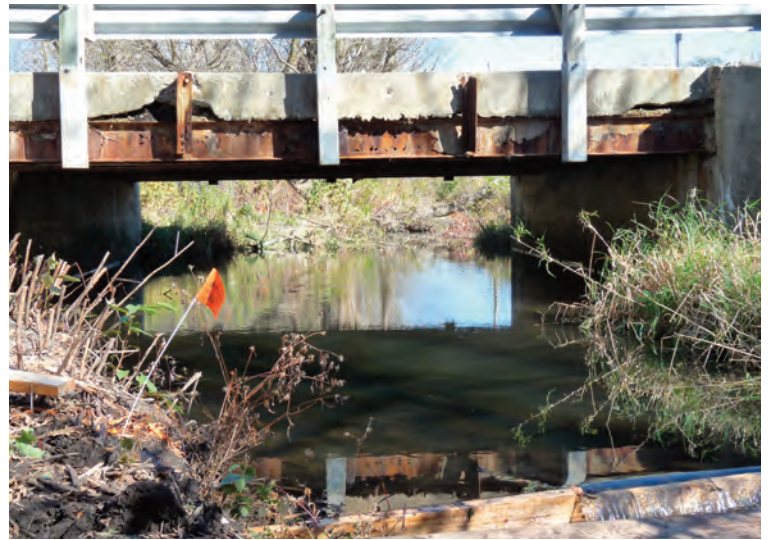
Plans to replace a 73-year-old bridge near Delavan ABOVE took on greater urgency after a portion of the bridge deck broke away, prompting Walworth County to restrict use by most vehicles. A shiny aluminum box culvert RIGHT, built on site and installed in one week by county crews, replaces the old bridge.

WALWORTH COUNTY replaced a bridge well past its prime last November with a low-cost solution that took only seven days to build. Budgeted for replacement in 2012, the Depression-era span north of the Town of Delavan moved to the top of the list in late summer when a chunk of concrete from the bridge deck fell into the creek. The County Highway Department inspected and reduced the load limit to five tons.

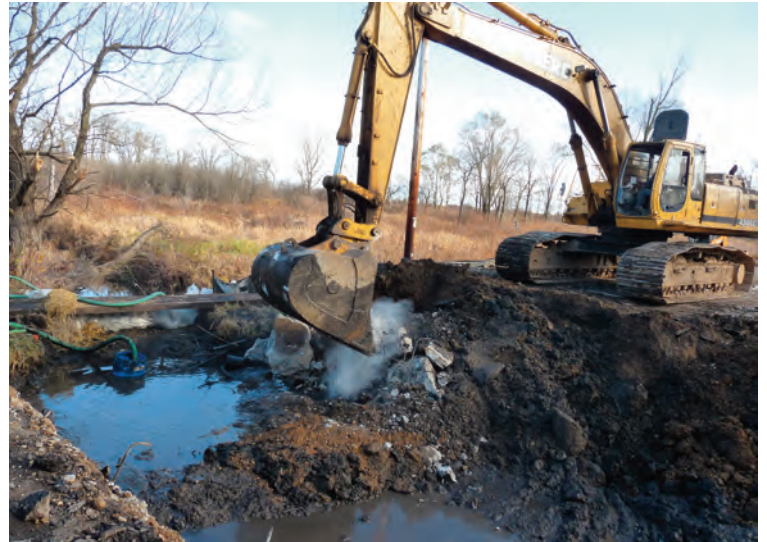
TOP: Local crews remove the old bridge deck and one abutment at the start of the one-week project. **CENTER:** Crews assemble the culvert on site. No individual piece was bigger than 4' by 6' and all weighed less than 100 lbs. **BOTTOM:** A crane lifts the new box culvert into place.

County workers began removal of the old bridge deck and one abutment on a Friday while crews from Contech delivered the structure to the site in pieces. Contech assembled the culvert over the weekend and on Monday, local crews were back to start pumping out the streambed, continue the tear down and haul away debris.

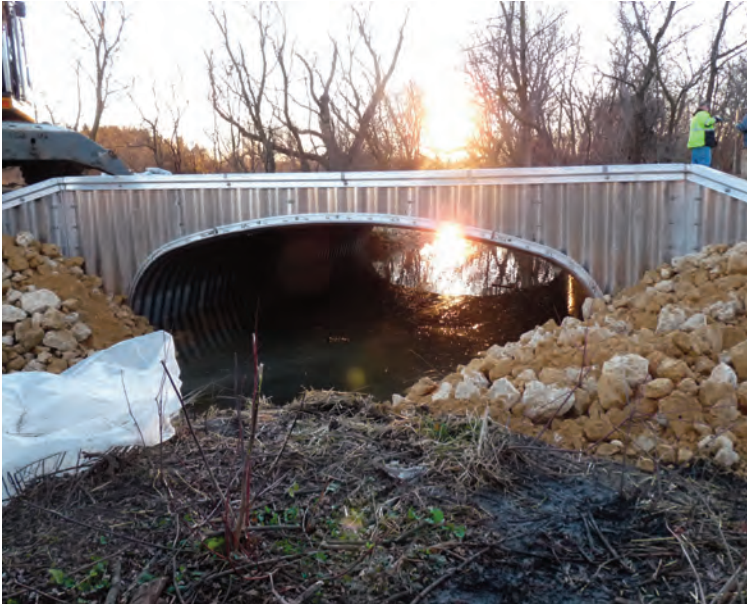
LEFT: The new bridge takes shape on day six with abutments in place and a rebuilt stream bank below. **TOP RIGHT:** The completed aluminum culvert bridge seen from below with stream flow restored and new guardrail in place. **BOTTOM RIGHT:** A view from the bridge approach to the new asphalt pavement.

After another day of excavating the site and putting in a new base for the structure, the county brought in a rented crane on Wednesday to lift the new box culvert into place. Poggensee says they then backfilled around the abutments with a slurry mix, compacted the materials, spread riprap on the stream bank and, by that afternoon, were driving across the new structure. Workers placed the asphalt on Thursday and they opened the road to traffic the next morning.
